# REPAIR INSTRUCTIONS

The following steps will determine if your vehicle has affected Ride Command software, and if a software update is required.

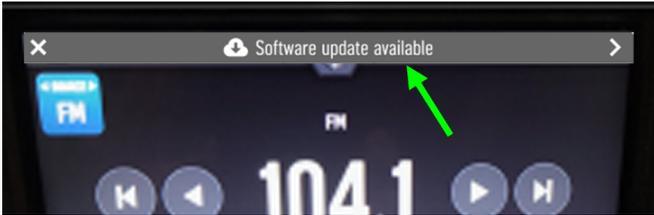
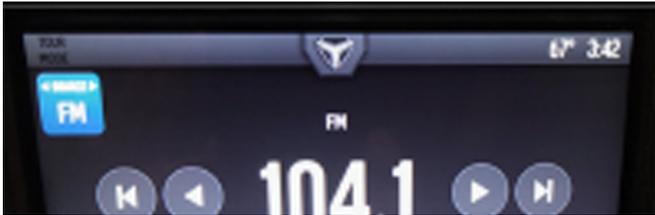
2. An Over The Air update was sent to Ride Command+ vehicles on **08/10/2023**. Does the update banner appear when powering on your vehicle?

<p data-bbox="154 1373 813 1461"><b>Perform update.</b> Polaris will monitor and close the recall for you once you complete the update. No further action required.</p>	<p data-bbox="1062 1404 1292 1432"><b>Proceed to Step 3.</b></p>

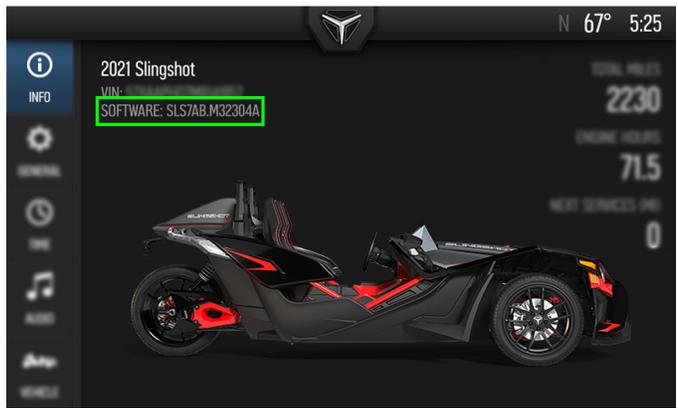
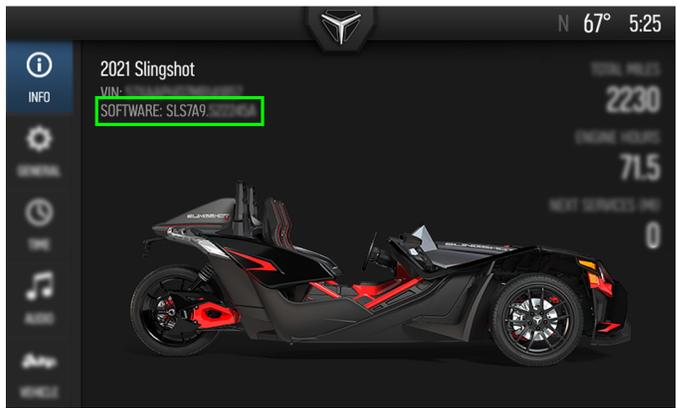
5. Do you have software SLS7AB.M32304A (APR 2023)?

<p>Vehicles with software SLS7AB.M32304A (APR 2023) require an update. <b>Proceed to Step 6.</b></p>	<p>Select <b>No Update</b> from the drop-down of the submission form.</p>
