POLARIS RACING

****Attention Polaris 2022 600R Racers***

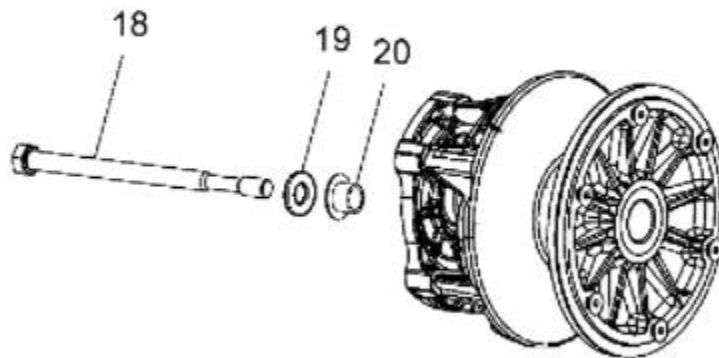
The Belleville washer (#19 in below picture) on the primary clutch bolt may have been installed backwards at the factory. Remove the primary clutch bolt and verify correct orientation of the belleville washer. The domed side outwards towards the bolt head. Re-install and torque the primary clutch bolt to 55ft/lbs. Run the sled on a jack stand and then re-torque the bolt to 55ft/lbs.
