SEAT BELT ANCHOR FASTENER VERIFICATION INSTRUCTIONS

2023-2025 RANGER XP 1000 NorthStar / Crew XP 1000 NorthStar https://www.youtube.com/watch?v=PNuHfx77p1Q

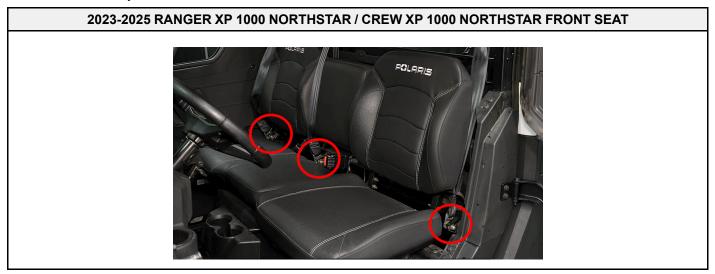
1. Reference the following images. On the lower back of the seat area, locate where the seat belt anchor is attached to the frame. Inspect to make sure the fasteners have been tightened by checking that the fasteners are tight and **DO NOT** move when turned by hand.

If any fasteners are found to not be tightened, you must stop operating the vehicle until repaired by an authorized Polaris dealer.

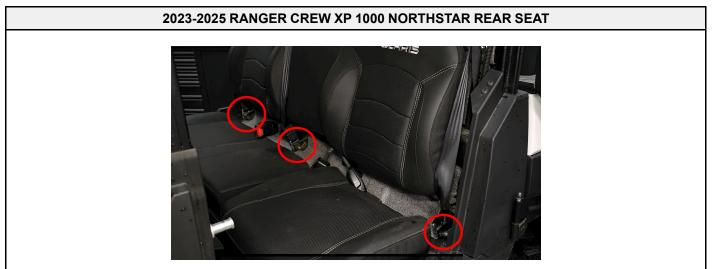
2. For multi passenger vehicles only, make sure the fasteners have been tightened by checking that the fasteners are tight and **DO NOT** move when turned by hand.
