****Attention Polaris 2025 600R SnoX Racers***

The MY25 600R Race sleds may have been built with the upper steering post blocks alignment indication hole on the opposite side (#5142857) it should be on. Before operating this vehicle, you must inspect the upper steering post block for correct orientation/alignment.

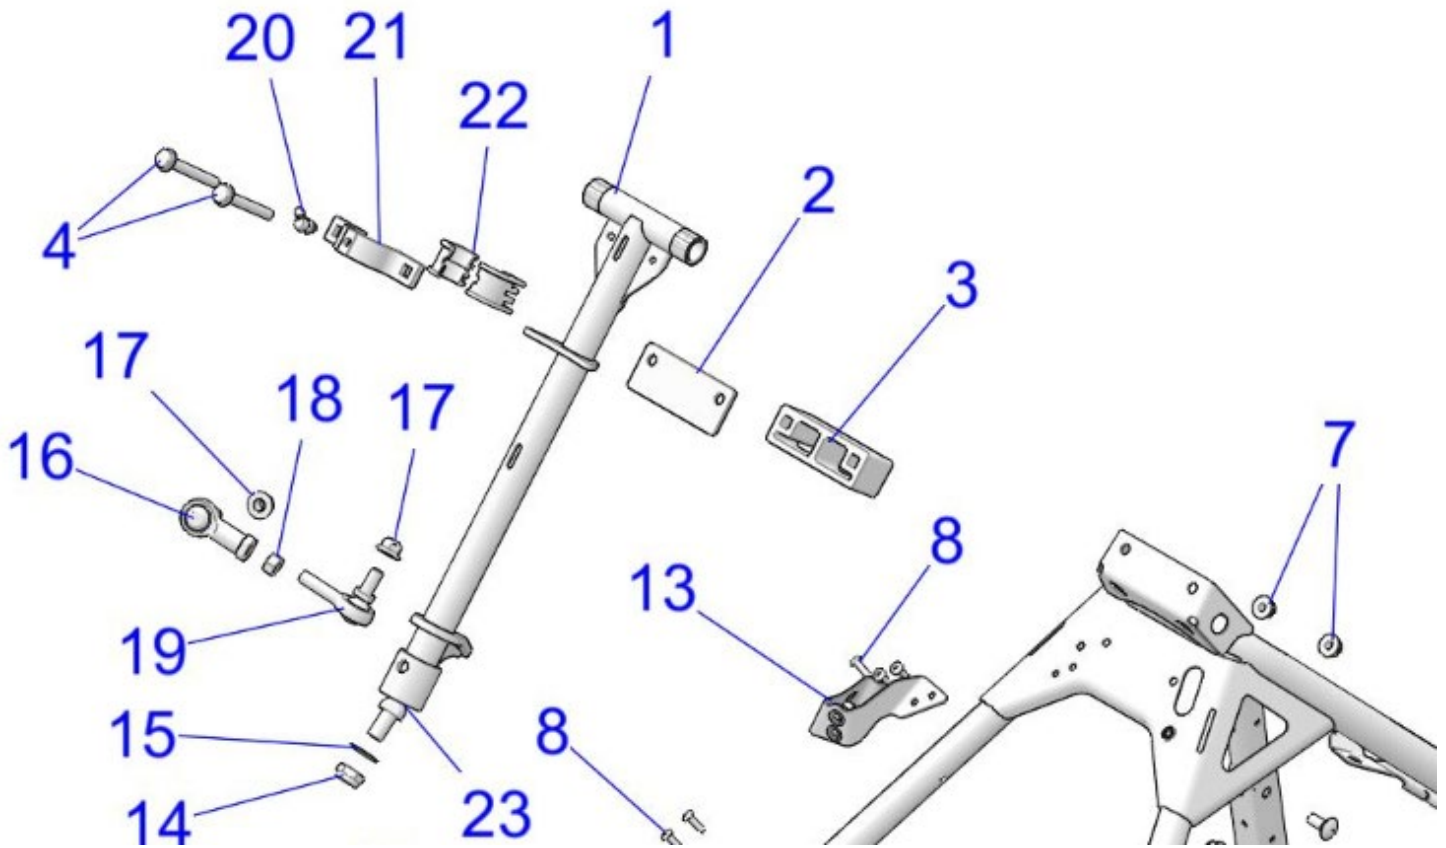
The #5142857 steering blocks location is **#3** in the below picture
